Full Inspection Report

Inspection Date 11/23/2016

Property Address: 123 Your Home Road, Sanford, NC 27330

VIP Inspection Services Inc. Brian Innerarity #3576 919-468-3114

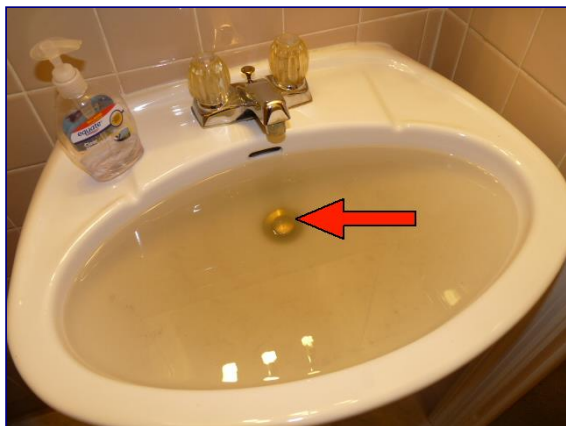
1

1. Master bathroom. The sink drain is slow or drains slower than the faucet fills it. An accidental overflow could occur.
 2. Kitchen faucet. When turned on, the faucet sprays. This suggests the strainer is damaged.

3. Guest bathroom sink. The sink is cracked through or the edge is sharp. This could leak at any time or cause injury.
 4. Guest bathroom sink. The pedestal sink is loose from the wall. It could fall without correction.

5. **The following interior kitchen, bath or laundry plumbing fixtures or drains had issues.** All listed should be corrected so they function as intended, do not leak and any surrounding damage to building materials should be corrected. A licensed plumbing contractor or other qualified contractor with plumbing repair experience should repair/replace or further investigate as applicable. If there are water stains associated with any leaks there is always the possibility of hidden contiguous moisture damage that was not visible during the inspection. Repair persons should check for be aware of and correct any hidden moisture damage during repairs or further investigations.

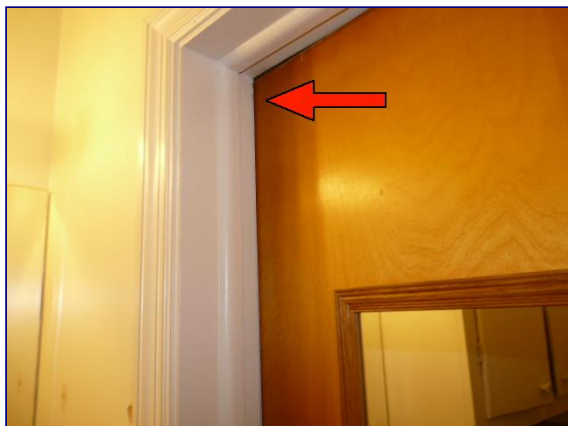
1

- 7. The following doors listed below have operating issues.** Doors with minor issues (in the inspector's opinion) will not be reported on. A licensed general contractor or other qualified contractor/person with door repair experience should repair or replace.
1. Master bathroom. The door hits the frame at the top and is more difficult to open/close.
 2. Dining room exterior door. The threshold weatherstripping is damaged.
 3. Dining room exterior door. The door pinches the frame on the left side and is more difficult to open/close.
 4. Guest bathroom. The door pinches the frame and is more difficult to open/close.

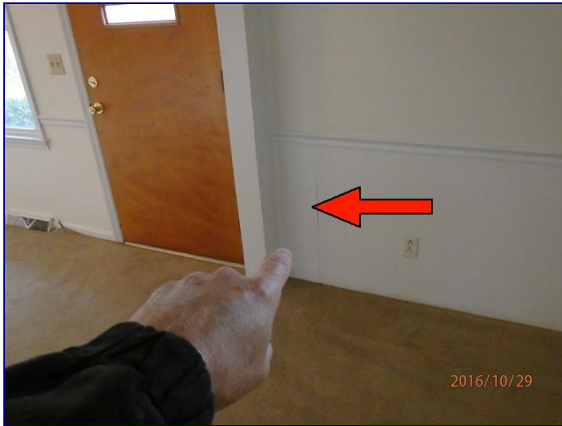
1

1. Living room. Right of the front door. The wall was soft and may have hidden moisture damage behind.
2. Back right bedroom. The ceiling has fungal growth and is stained.

8. **Interior stains - Interiors.** The following interior areas/rooms have water stains on floors, walls or ceilings as applicable. Stains can represent past corrected issues or small active leaks that are just dry at the time of the inspection. Since we are not familiar with the house and our visit is for a short time, it is prudent that all stains be considered active leaks until proven otherwise to your satisfaction. Often owners or occupants have more intimate knowledge and can disclose further information, it is a good idea to ask for copies of work orders if they exist. **If documented evidence of repairs or written satisfactory disclosure is not available then a licensed general contractor, plumbing contractor or roofing contractor as applicable should further investigate and after their evaluation make repairs or replacements as necessary. This report is not a guarantee against leaks.**

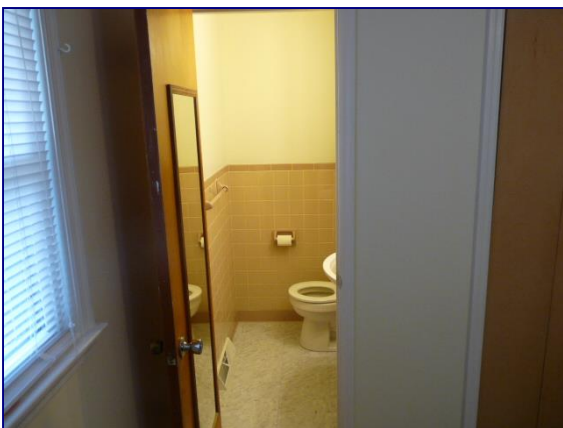
9. Master bathroom does not have an exhaust fan nor a window. Moisture problems could occur. A licensed electrical contractor or other qualified contractor with electrical repair experience should further investigate and repair or replace as needed.

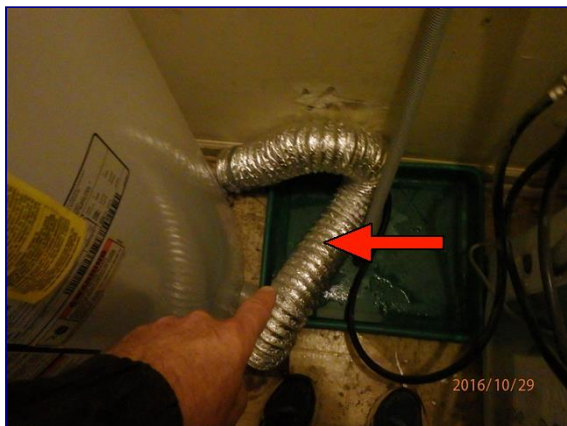
10. The laundry room, crawl space or other area as applicable. The dryer duct or portion of it is flexible thin foil or plastic. These are no longer approved for use and are considered fire safety hazards. A licensed general contractor, dryer appliance installer or other qualified contractor with current dryer duct installation knowledge should repair or replace, checking the whole length.

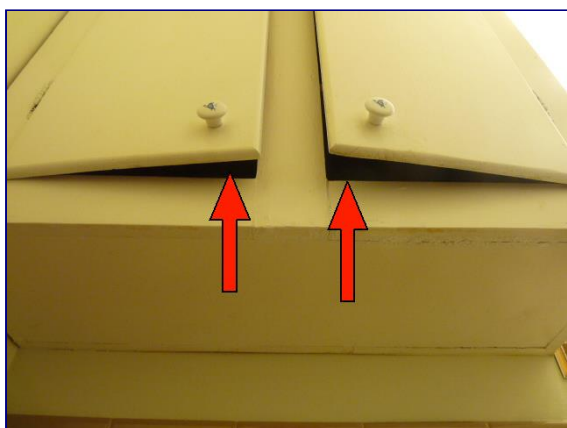
1

1. Master bathroom. Cabinet/s above the toilet. The cabinet doors will not close or stay closed.

11. The following cabinets have issues. They could cause injury or property damage if not corrected. All should be repaired or replaced by a licensed general contractor or other qualified contractor.

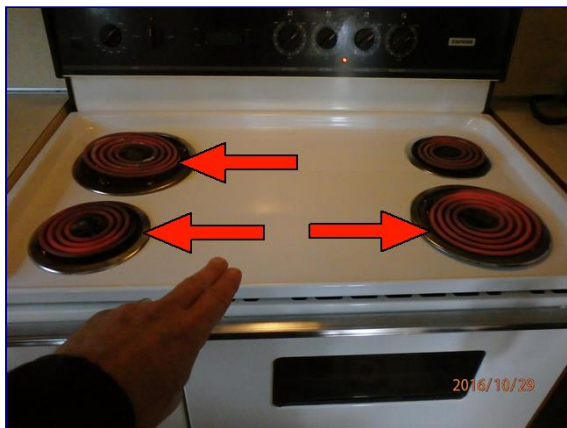
1

1. One or more of the burners do not sit properly in the grease pans. Evidence suggest the burners or the grease pans are the wrong size.

12. Kitchen. The stove has the following issues. An appliances repair technician or other qualified contractor should repair or replace.

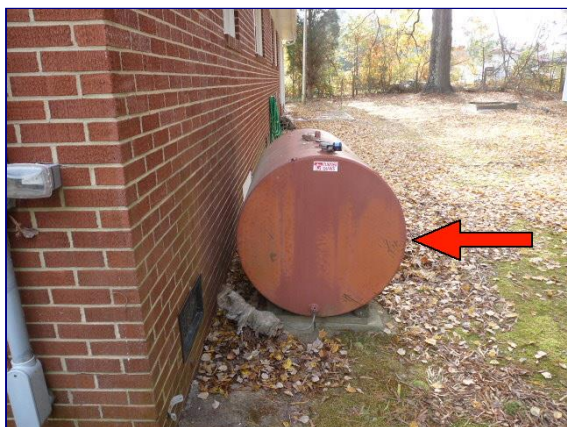
15. Unless mentioned in the summary the hose faucets functioned as intended today. This is for your information.
16. Outside facing the back of the house. There is an abandoned oil tank. These tanks can represent safety and long term health hazards. A qualified tank removal company should remove and dispose of the tank and its related equipment.

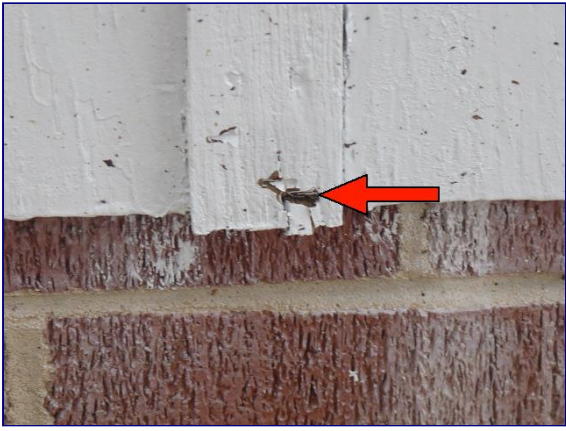
1

1. Attached storage shed. One or more vertical trim pieces between the siding boards are moisture damaged at the bottom.
2. Front door. There is moisture damage to the lower door jamb on both sides.

- 18. The following areas have damage, moisture damage, dry rot, decay or need preparation and paint.** Some areas are small dime size sections, some are larger and more obvious. Some areas may just need preparation, paint and sealants, some damage may need filling or patching and others areas may need actual replacement of materials. Further damage to these areas could result in more expensive repairs without correction. A licensed general contractor or other qualified contractor/person should further evaluate the areas in the photos and repair or replace as necessary. ***The contractor who performs this work should check for and correct any other areas of the exterior envelope that show damage, moisture or otherwise. They should also check for hidden contiguous moisture damage during repairs, that is not always visible. Leaks or damage can hide moisture damage bigger and in worse condition than the visible areas.*** We cannot and do not pull siding or trim loose to inspect. Not all areas can be probed/checked during my short visit. This is a representative visual inspection and not every piece or component of the exterior is or can be probed or checked.

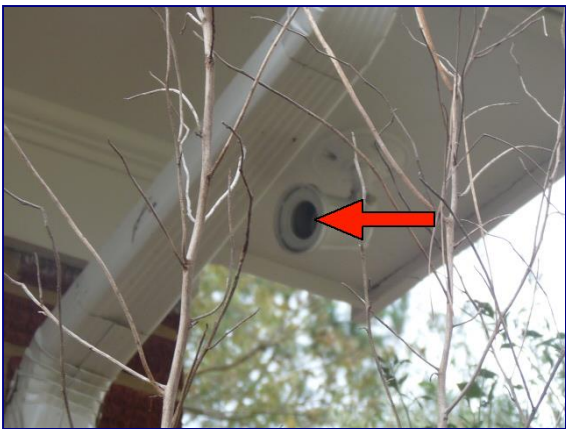
Front right corner floodlight

- 19. One or more of the exterior light fixtures did not work. A qualified person should replace or install bulbs first, if the problem still exists, then a licensed electrical contractor should repair or replace as needed. Switches are not always in obvious places. We do not test lights on photo, motion or time sensors. Check all.

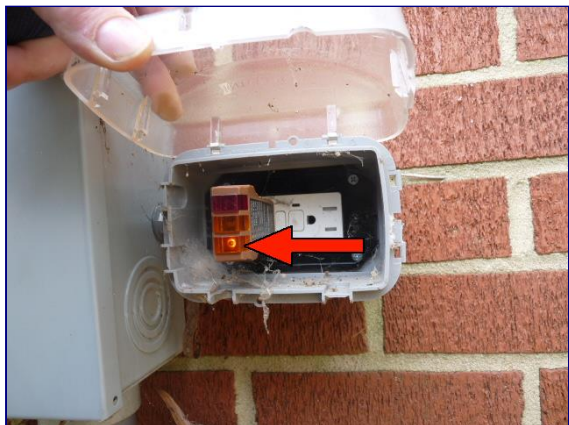
1

1. Outside facing the right side of the house. The outlet has an open neutral.
2. Covered car port. The outlet has a missing weather proof cover. Water penetration can cause corrosion, shorts or an electrocution hazard.
3. Covered car port and the attached storage shed. The wall outlets have an open ground. This is a hazard.
4. Inside the well house. There is expose high voltage wiring at the well pump. All exposed wiring should be put in conduits for safety.

- 20. **The exterior has the following electric issues.** These are safety or property hazards. All should be corrected so they are safe for use and function as intended. A licensed electrical contractor, other qualified person with electrical repair experience or more specific person listed below should repair or replace.

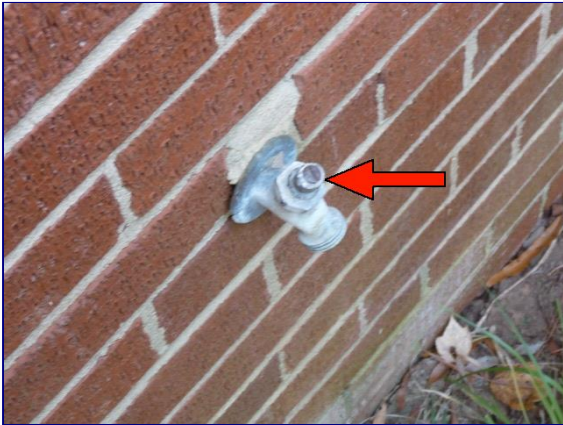
1

21. The following hose faucets have issues and should be corrected so they function as intended. A licensed plumbing contractor or other qualified contractor/person with plumbing repair experience should repair or replace.
1. Outside facing the front of the house. The hose faucet handle is missing. The faucet is not useable, was difficult to or could not be operated.
 2. Outside facing the back of the house. The hose faucet handle is missing. The faucet is not useable, was difficult to or could not be operated.

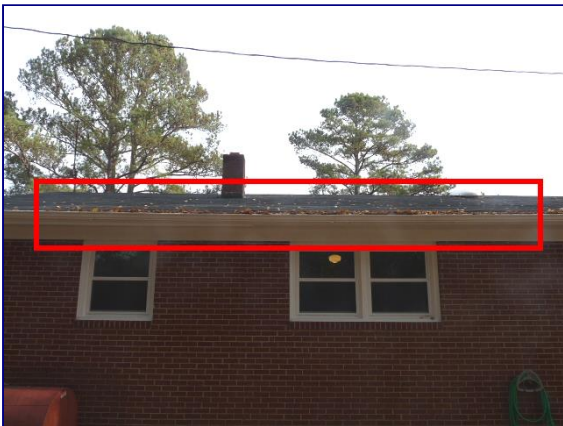
22. The gutters or gutter guards have debris in places and should be inspected and cleaned. The debris in gutters can also conceal rust, deterioration or leaks that are not visible until cleaned, and I am unable to determine if such conditions exist. A qualified person or contractor should clean the gutters and then inspect the gutters and the areas behind the gutters for any contiguous moisture damage and repair or replace as and if needed.

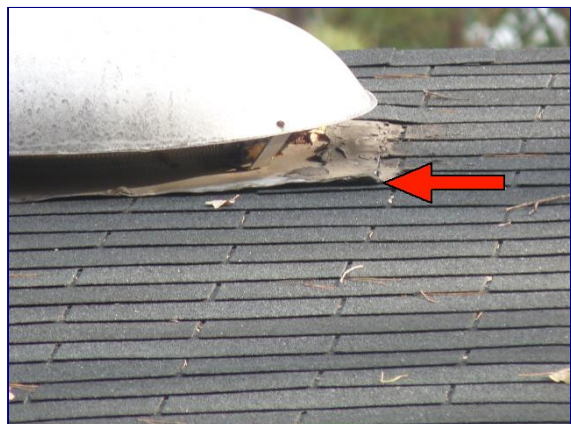
1

1. Outside facing the back of the house. One or more of the plumbing vent boot is weathered, lifted/loose, worn or has rusted exposed nail heads. Leaks could develop at anytime without correction. Most professionals just replace all the roof boots at the same time when one fails the others are close behind.
2. Around the chimney. The flashing is raised up or not secured. This can lead to leaks.

23. The roof coverings, penetrations, flashings or other components have the following issues. If not corrected leaks could develop at any time. A qualified roofing contractor or other qualified contractor with roof repair experience should check the roof for these and any other issues and repair or replace as needed.

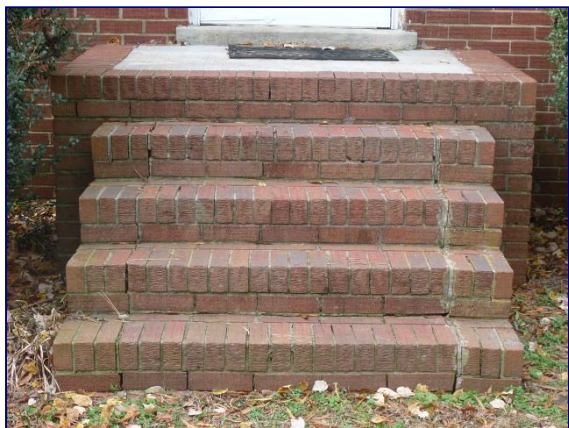
1

- 24. Outside facing the front of the house. (reference the front door). The porch has the following issues.** All should be corrected to prevent trip hazards, water penetration or other issues. A licensed general contractor or other qualified contractor should repair or replace.
1. Most professionals recommend that stairs which require 3 or more movements between landings should have hand rails installed for safety reasons.
 2. The steps are leaning or settling. This can be trip hazard. Also the mortar joints in and around the steps have some cracked and damaged areas. Water can get into these joints and through freeze and thaw cycles make them worse.

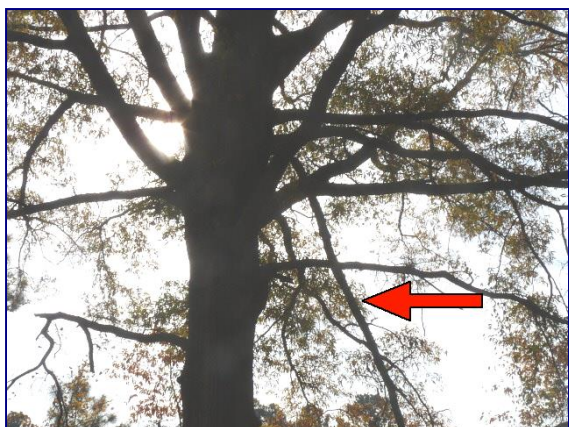
- 25. Outside facing the back of the house. The trees have several dead branch hanging loose. This is a hazard. A tree trimming or arborist should trim the trees to address any dead or weak branches over the house or the yard.

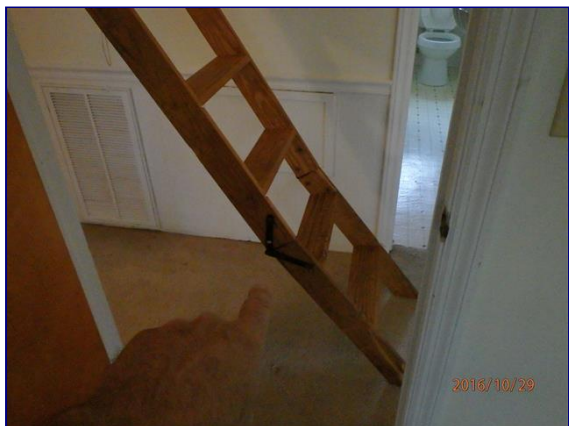
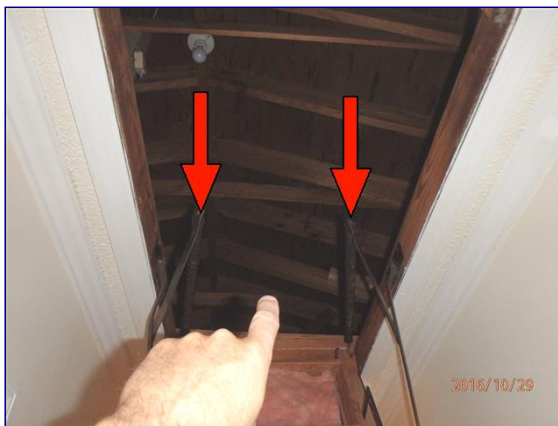
2

26. The pull down stairs have the following issues. All should be corrected for safety or other reasons. A licensed general contractor or other qualified contractor should repair or replace.
1. The stairs are the wrong length. The bottom section is angled when it rests on the floor or weight is applied. The angle is putting excessive pressure on the lower stair hinges and hardware when weight is applied.
 2. The return springs/hardware are bent or damaged and are sticking out into the opening. This makes it hard to navigate the steps and is causing difficulty closing the stairs.

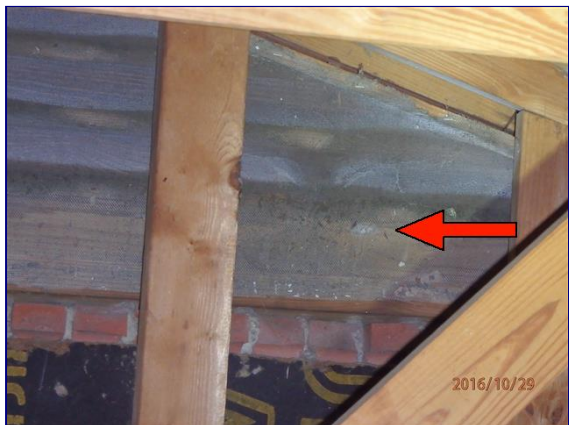
27. From inside the attic. The attic gables have plant, insect, rodent, animal or other debris in them on the outside of the screens. Some of this can be hazardous to humans. A licensed general contractor or other qualified contractor should repair or replace a pest control contractor may be needed for animals/insects.

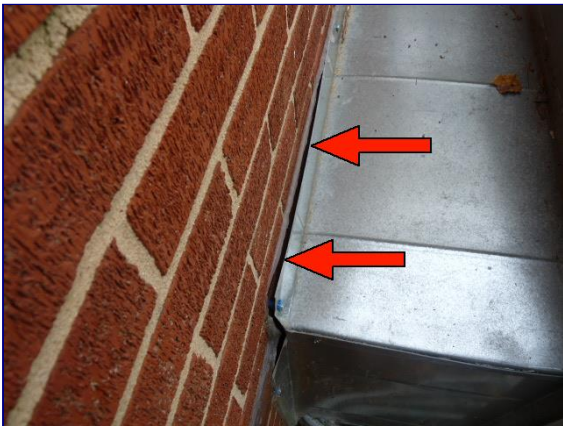
1

1. The sealant on the metal hood or between the hood and the wall are missing, damaged or deteriorated. This could let water into the crawl space or duct work under the hood.

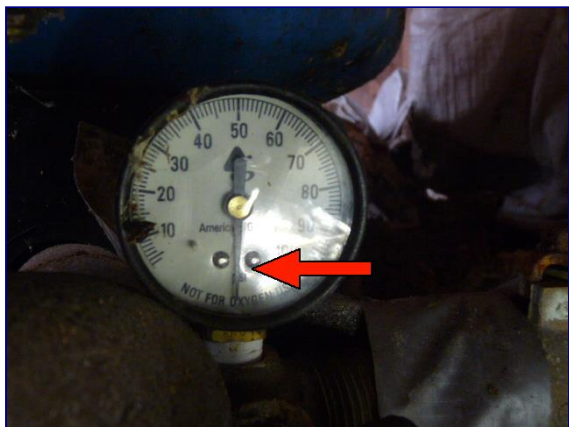
30. The well pump tank. The pressure gauge is showing zero PSI. Pressure in the house was adequate today. This indicates an issues with the pressure valve. A licensed plumbing contractor or other qualified contractor/person with plumbing repair experience should repair or replace.

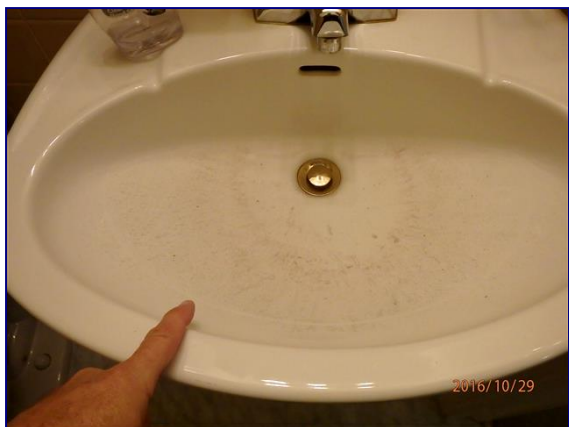
31. The hot water supply in the house had a rotten egg smell and debris during my visit. I am not a water treatment specialist. This issue should be further investigate by a water treatment contractor or licensed plumbing contractor to determine the cause, method of correction and make sure there is not a health concern.

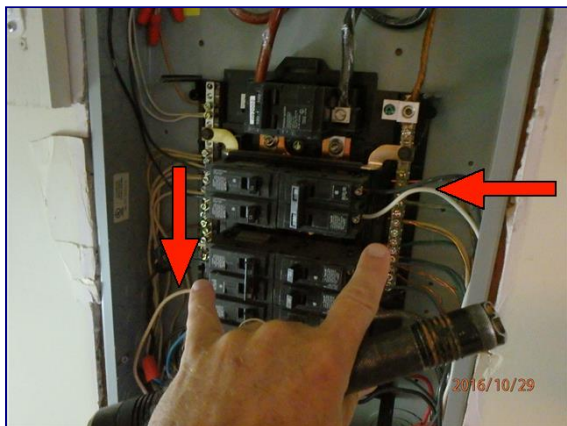
1

1. One or more white wires are being used for hot wires and have not been marked as such. Most professionals agree that they should be marked at the panel and at the far/other end for safety reasons.
2. There are doubled up common (white) wires on the buss bar, this is a safety hazard. This may not have been a code requirement at the time of construction, I do not know. However that is a question for the electrician to decide.
3. One or more of the wires in the panel is missing or has damaged protective cable grommets. The grommets protect the wires from the sharp metal casing.
4. At least one or more of the circuits are not labelled or are hard to read.

32. **The sub electric panel has the following issues.** All electrical issues are considered fire, shock or other hazards until corrected. A licensed electrical contractor should investigate and repair or replace.

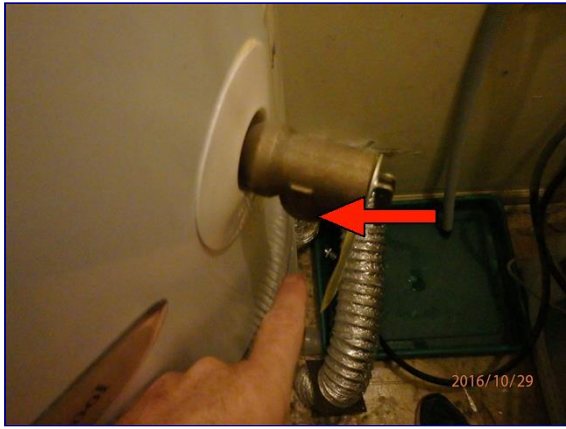
1

1. The water heater's temperature and pressure relief valve is missing the drain line. An accidental scalding could occur if the valve opens.
2. The hot water heater has been installed behind the washer and dryer. The hot water heater is not accessible without having to move the washer and dryer out of the way. Hot water heaters should be easily accessible.
3. The water heater inlet lines are flexible rubber braided lines. Most professionals do not use them because of high failure rates. Also the rubber deteriorates under pressure and heat and small flakes of the rubber end up in the water.

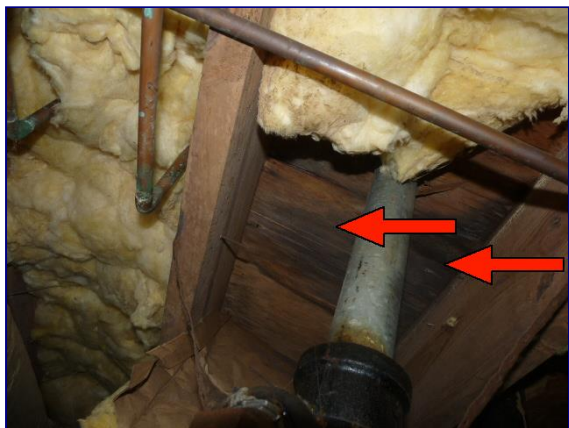
1

1. Facing front from outside(reference the front door). Then at the back of the crawl space. The plywood subflooring has dark stains and had moisture readings in excess of 25%. Evidence suggest the drain is leaking.

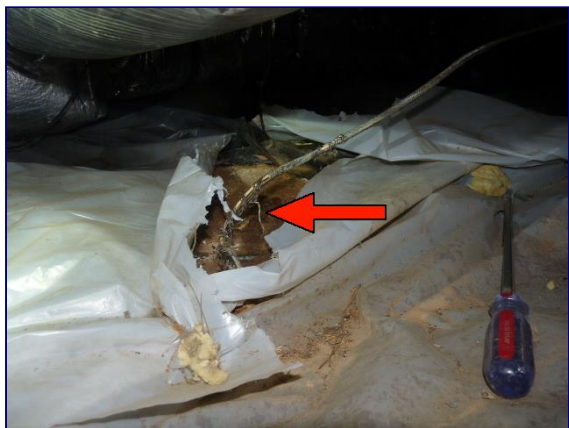
1

1. There are several wires that appear to be abandoned. I did not test to see if these wires are still active.
2. The wiring has open/exposed splices or ends. This is an electric safety hazard. Most professionals agree that all splices should be in approved boxes. Just capping the ends with wire nuts or taping the ends is not considered safe enough. Abandoned wires or circuits should be removed.
3. The electric wires are loose and hanging down or are not attached to the wood members. This is a hazard to persons.

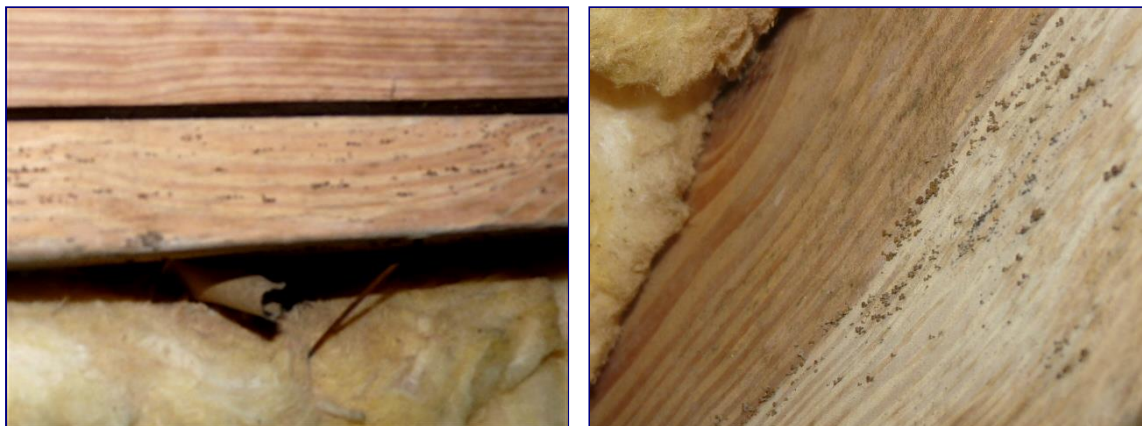
- 36. Crawl space. There are fungal growth on the wood framing. Fungal growths can be a health hazard and cause wood rot. Evidence suggests the cause is excess moisture from time to time. The summary will state if we noted excess or harmful moisture today. A licensed general or fungal remediation contractor should further investigate and correct as necessary and address the underlying cause to prevent reoccurrence.

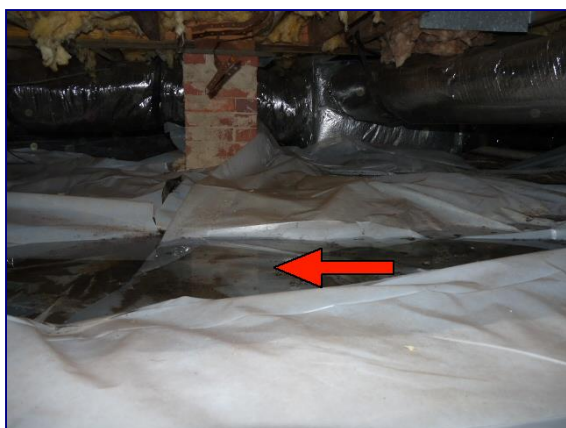
37. At the front middle section. There is a puddle of water on top of the vapor barrier. I could not verify the source of the standing water. This will increase the moisture levels in the crawl space. Verify if the water is pre-existing or if caused by a leaking plumbing pipe. A licensed plumbing contractor or other qualified contractor/person with plumbing repair experience should repair or replace.

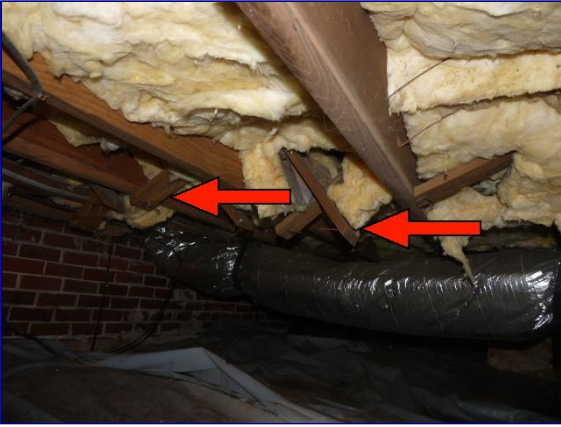
38. Crawl space. Several of the floor joists cross members are not secured or have come disconnected from the joists. These keep the joists from turning or rotating. A licensed general contractor or other qualified contractor should repair or replace.

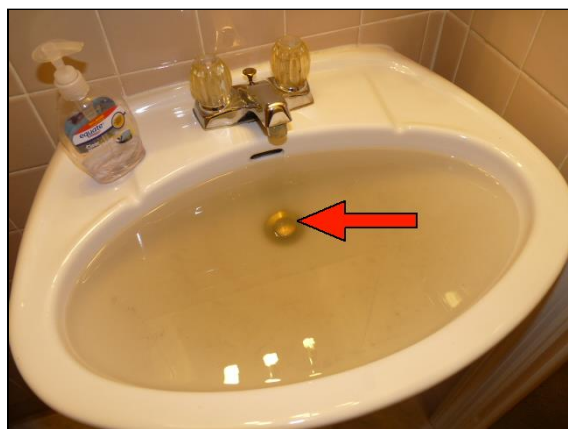
1

1. Master bathroom. The sink drain is slow or drains slower then the faucet fills it. An accidental overflow could occur.
2. Kitchen faucet. WHEN turned on, the faucet sprays. This suggest the strainer is damaged.
3. Guest bathroom sink. The sink is cracked through or the edge is sharp. This could leak at any time or cause injury.
4. Guest bathroom sink. The pedestal sink is loose from the wall. It could fall without correction.

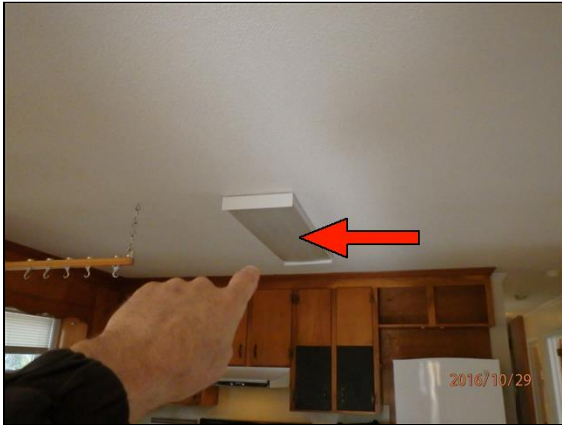
1

1. Kitchen ceiling fluorescent fixture. The three way switches for the light fixture/s did not work correctly. The fixture/s should be fully controllable from both switches regardless of the switch position at the other side. The switches are not functioning as intended. Also, the fluorescent flickers when turned on.
2. Hallway. The electric outlet/box is missing a cover plate. This is an electric safety hazard.

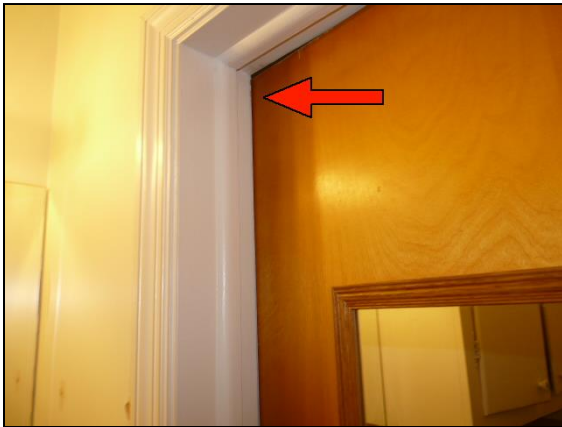
1

1. Master bathroom. The door hits the frame at the top and is more difficult to open/close.
2. Dining room exterior door. The threshold weatherstripping is damaged.
3. Dining room exterior door. The door pinches the frame on the left side and is more difficult to open/close.
4. Guest bathroom. The door pinches the frame and is more difficult to open/close.

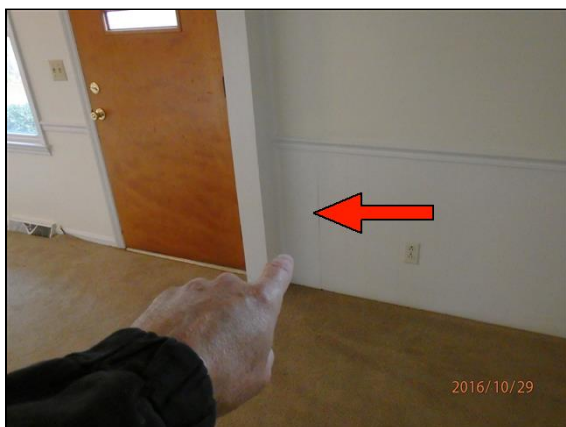
1

- 1. Living room. Right of the front door. The wall was soft and may have hidden moisture damage behind.
- 2. Back right bedroom. The ceiling has fungal growth and is stained.

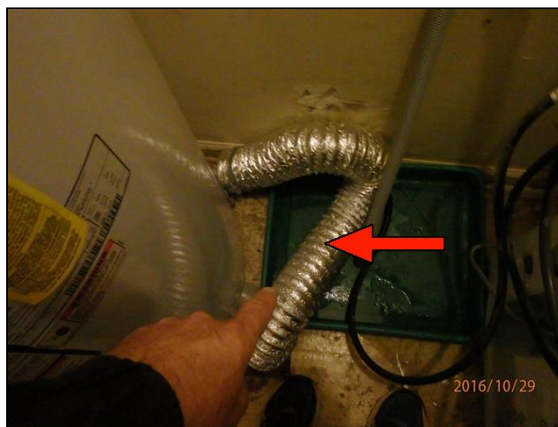
1.9 The laundry room, crawl space or other area as applicable. The dryer duct or portion of it is flexible thin foil or plastic. These are no longer approved for use and are considered fire safety hazards. A licensed general contractor, dryer appliance installer or other qualified contractor with current dryer duct installation knowledge should repair or replace, checking the whole length.

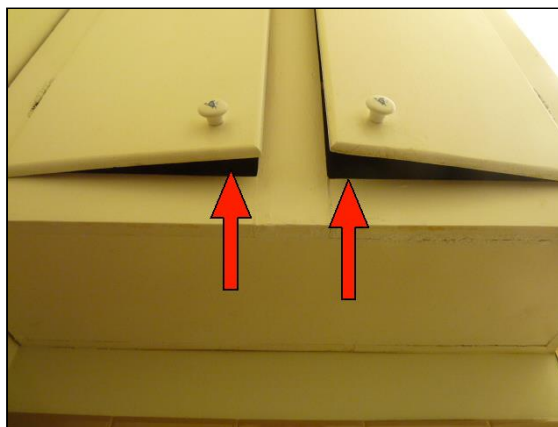
1

1. Master bathroom. Cabinet/s above the toilet. The cabinet doors will not close or stay closed.

1.10 The following cabinets have issues. They could cause injury or property damage if not corrected. All should be repaired or replaced by a licensed general contractor or other qualified contractor.

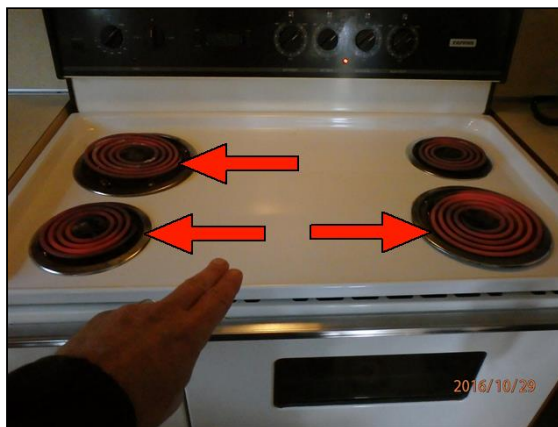
1

1. One or more of the burners do not sit properly in the grease pans. Evidence suggest the burners or the grease pans are the wrong size.

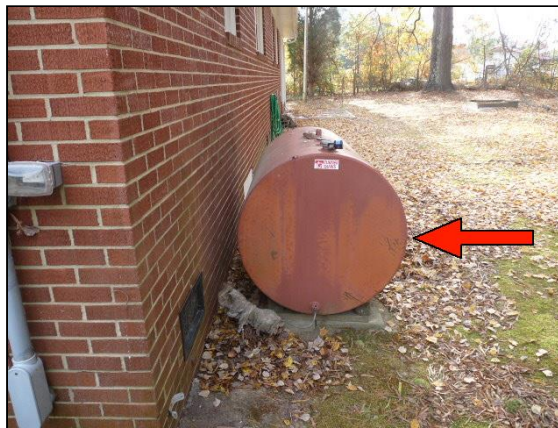
2.0 Outside facing the back of the house. There is an abandoned oil tank. These tanks can represent safety and long term health hazards. A qualified tank removal company should remove and dispose of the tank and its related equipment.

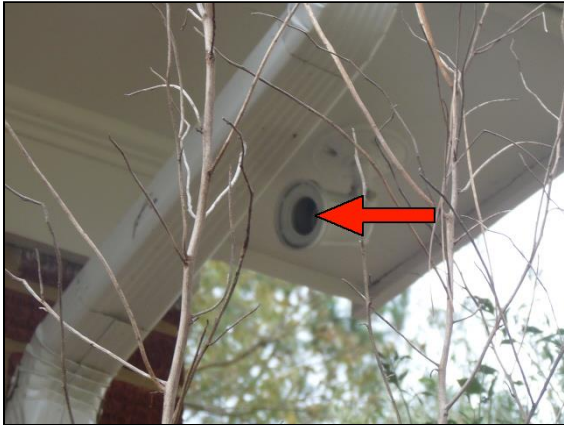
Front right corner floodlight

2.5 One or more of the exterior light fixtures did not work. A qualified person should replace or install bulbs first, if the problem still exists, then a licensed electrical contractor should repair or replace as needed. Switches are not always in obvious places. We do not test lights on photo, motion or time sensors. Check all.

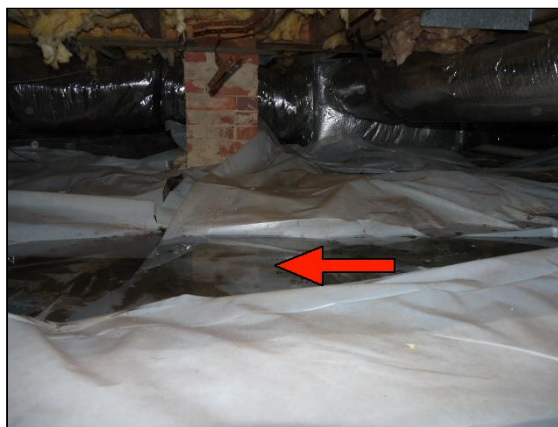
6.5 At the front middle section. There is a puddle of water on top of the vapor barrier. I could not verify the source of the standing water. This will increase the moisture levels in the crawl space. Verify if the water is pre-existing or if caused by a leaking plumbing pipe. A licensed plumbing contractor or other qualified contractor/person with plumbing repair experience should repair or replace.
