Full Inspection Report

Inspection Date 11/23/2016

Property Address: 123 Your Home Road, Sanford, NC 27330

VIP Inspection Services Inc. Brian Innerarity #3576 919-468-3114

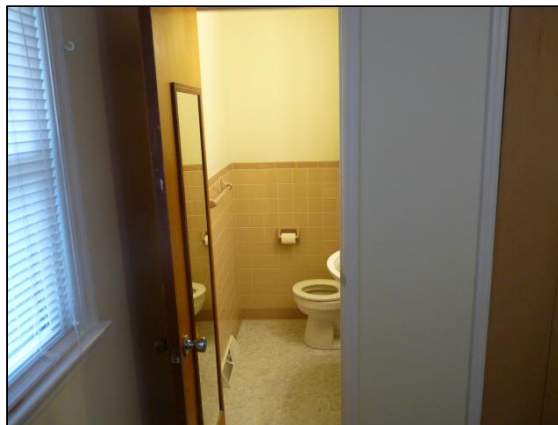
1.9 Master bathroom does not have an exhaust fan nor a window. Moisture problems could occur. A licensed electrical contractor or other qualified contractor with electrical repair experience should further investigate and repair or replace as needed.

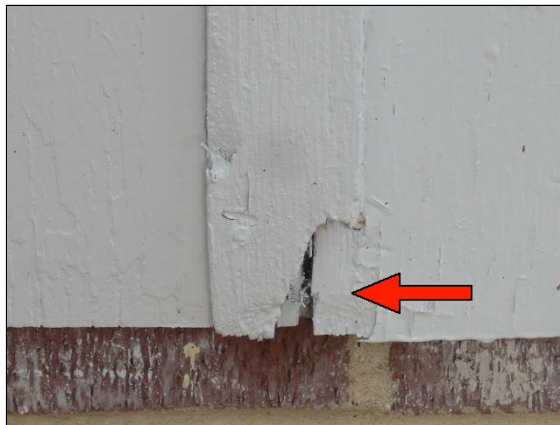
1

1. Attached storage shed. One or more vertical trim pieces between the siding boards are moisture damaged at the bottom.

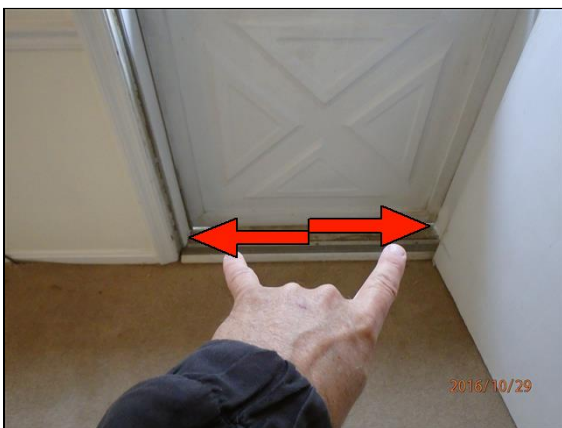
2

2. Front door. There is moisture damage to the lower door jamb on both sides.

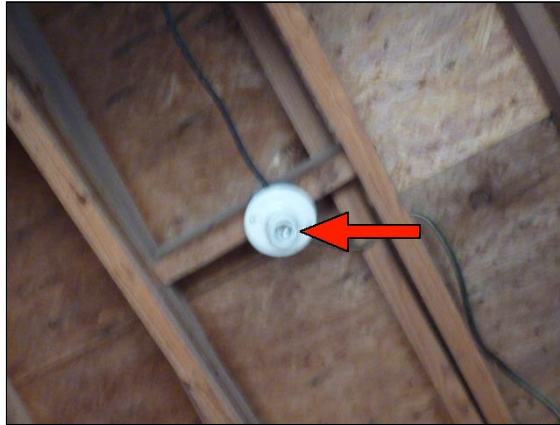
Attached storage shed interior ceiling fixture

2.5 One or more of the exterior light fixtures did not work. A qualified person should replace or install bulbs first, if the problem still exists, then a licensed electrical contractor should repair or replace as needed. Switches are not always in obvious places. We do not test lights on photo, motion or time sensors. Check all.

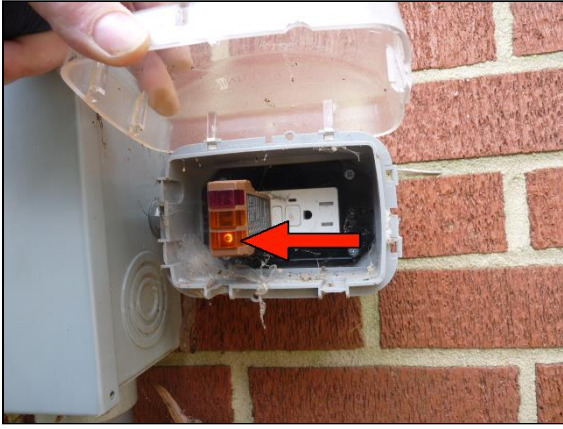
1

1. Outside facing the right side of the house. The outlet has an open neutral.
2. Covered car port. The outlet has a missing weather proof cover. Water penetration can cause corrosion, shorts or an electrocution hazard.
3. Covered car port and the attached storage shed. The wall outlets have an open ground. This is a hazard.
4. Inside the well house. There is expose high voltage wiring at the well pump. All exposed wiring should be put in conduits for safety.

2.5 The exterior has the following electric issues. These are safety or property hazards. All should be corrected so they are safe for use and function as intended. A licensed electrical contractor, other qualified person with electrical repair experience or more specific person listed below should repair or replace.

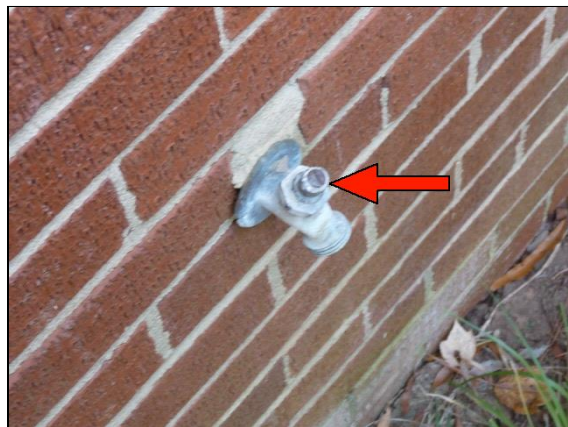
1

1. Outside facing the front of the house. The hose faucet handle is missing. The faucet is not useable, was difficult to or could not be operated.

2.7 The following hose faucets have issues and should be corrected so they function as intended. A licensed plumbing contractor or other qualified contractor/person with plumbing repair experience should repair or replace.

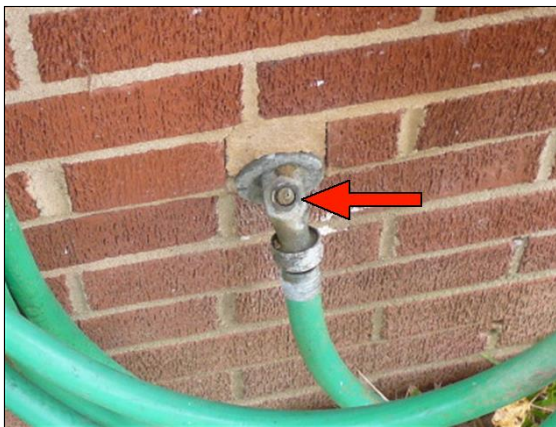
2

2. Outside facing the back of the house. The hose faucet handle is missing. The faucet is not useable, was difficult to or could not be operated.

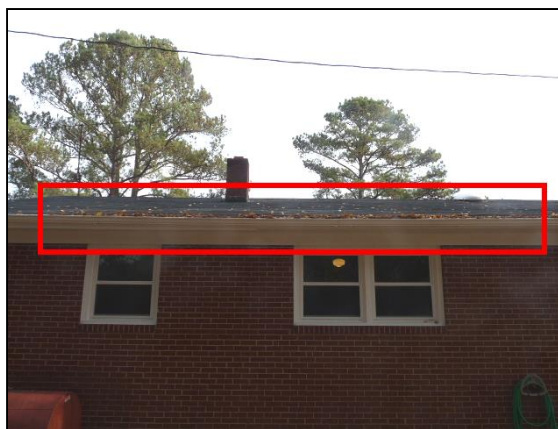
2.8 The gutters or gutter guards have debris in places and should be inspected and cleaned. The debris in gutters can also conceal rust, deterioration or leaks that are not visible until cleaned, and I am unable to determine if such conditions exist. A qualified person or contractor should clean the gutters and then inspect the gutters and the areas behind the gutters for any contiguous moisture damage and repair or replace as and if needed.

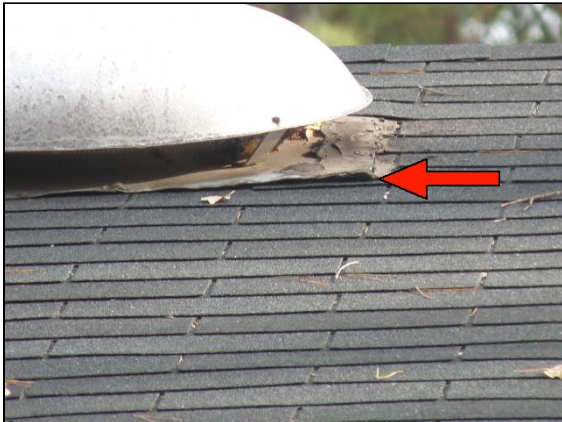
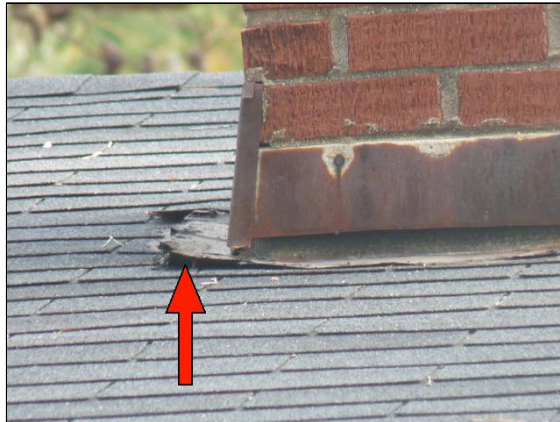
1. Outside facing the back of the house. One or more of the plumbing vent boot is weathered, lifted/loose, worn or has rusted exposed nail heads. Leaks could develop at anytime without correction. Most professionals just replace all the roof boots at the same time when one fails the others are close behind.

2. Around the chimney. The flashing is raised up or not secured. This can lead to leaks.

2.9 The roof coverings, penetrations, flashings or other components have the following issues. If not corrected leaks could develop at any time. A qualified roofing contractor or other qualified contractor with roof repair experience should check the roof for these and any other issues and repair or replace as needed.

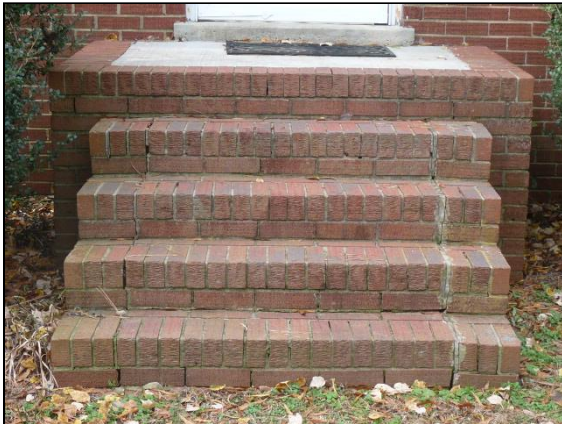
1

1. Most professionals recommend that stairs which require 3 or more movements between landings should have hand rails installed for safety reasons.
2. The steps are leaning or settling. This can be trip hazard. Also the mortar joints in and around the steps have some cracked and damaged areas. Water can get into these joints and through freeze and thaw cycles make them worse.

2.12 Outside facing the front of the house. (reference the front door). The porch has the following issues. All should be corrected to prevent trip hazards, water penetration or other issues. A licensed general contractor or other qualified contractor should repair or replace.

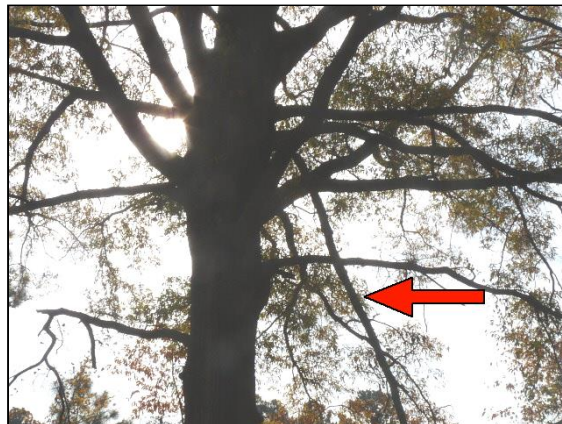
2.14 Outside facing the back of the house. The trees have several dead branch hanging loose. This is a hazard. A tree trimming or arborist should trim the trees to address any dead or weak branches over the house or the yard.

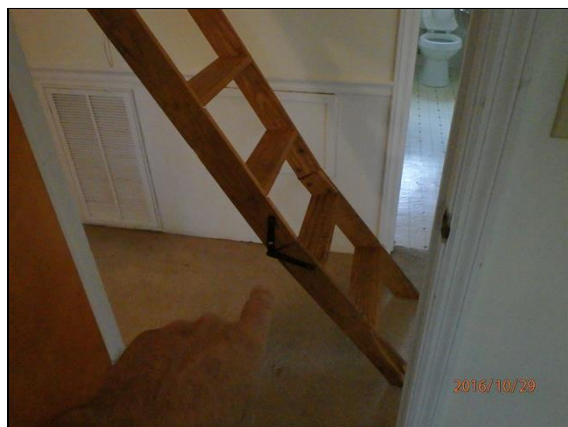
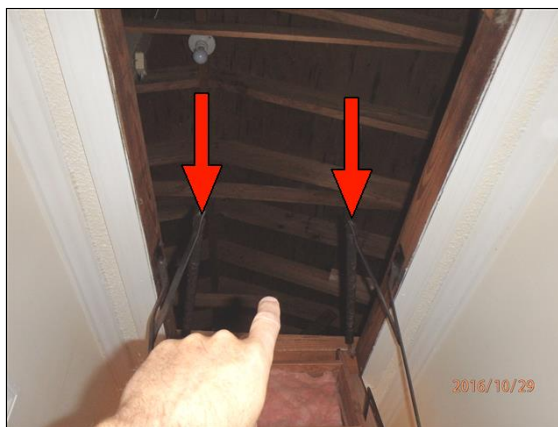
2

1. The stairs are the wrong length. The bottom section is angled when it rests on the floor or weight is applied. The angle is putting excessive pressure on the lower stair hinges and hardware when weight is applied.
2. The return springs/hardware are bent or damaged and are sticking out into the opening. This makes it hard to navigate the steps and is causing difficulty closing the stairs.

3.2 The pull down stairs have the following issues. All should be corrected for safety or other reasons. A licensed general contractor or other qualified contractor should repair or replace.

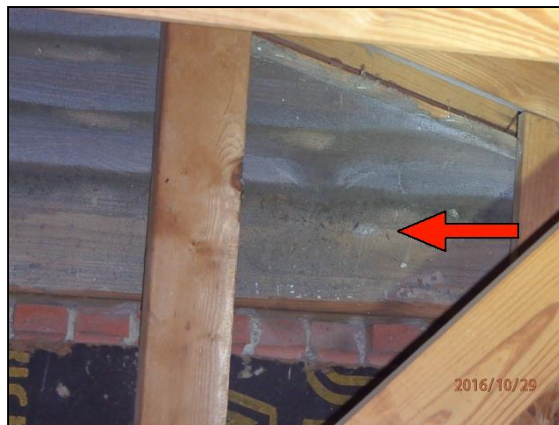
3.4 From inside the attic. The attic gables have plant, insect, rodent, animal or other debris in them on the outside of the screens. Some of this can be hazardous to humans. A licensed general contractor or other qualified contractor should repair or replace a pest control contractor may be needed for animals/insects.

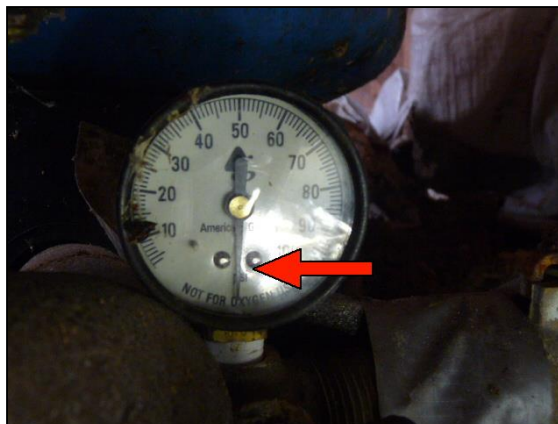
5.0 The well pump tank. The pressure gauge is showing zero PSI. Pressure in the house was adequate today. This indicates an issues with the pressure valve. A licensed plumbing contractor or other qualified contractor/ person with plumbing repair experience should repair or replace.

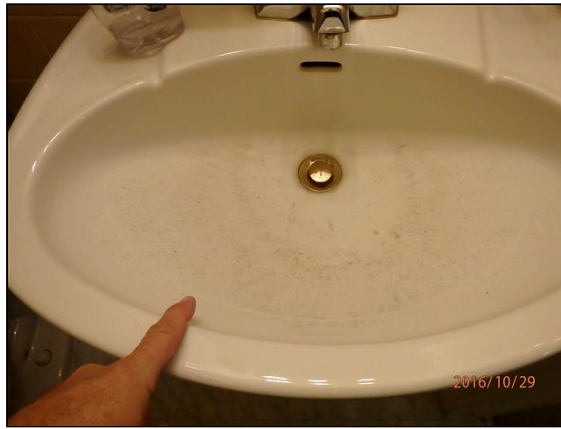
5.0 The hot water supply in the house had a rotten egg smell and debris during my visit. I am not a water treatment specialist. This issue should be further investigate by a water treatment contractor or licensed plumbing contractor to determine the cause, method of correction and make sure there is not a health concern.

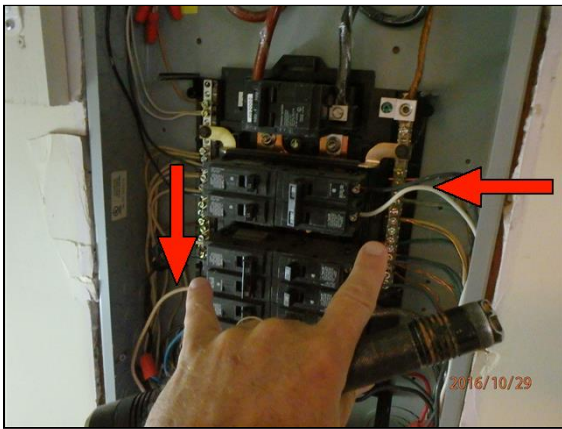
1

1. One or more white wires are being used for hot wires and have not been marked as such. Most professionals agree that they should be marked at the panel and at the far/other end for safety reasons.
2. There are doubled up common (white) wires on the buss bar, this is a safety hazard. This may not have been a code requirement at the time of construction, I do not know. However that is a question for the electrician to decide.
3. One or more of the wires in the panel is missing or has damaged protective cable grommets. The grommets protect the wires from the sharp metal casing.
4. At least one or more of the circuits are not labelled or are hard to read.

5.0 The sub electric panel has the following issues. All electrical issues are considered fire, shock or other hazards until corrected. A licensed electrical contractor should investigate and repair or replace.

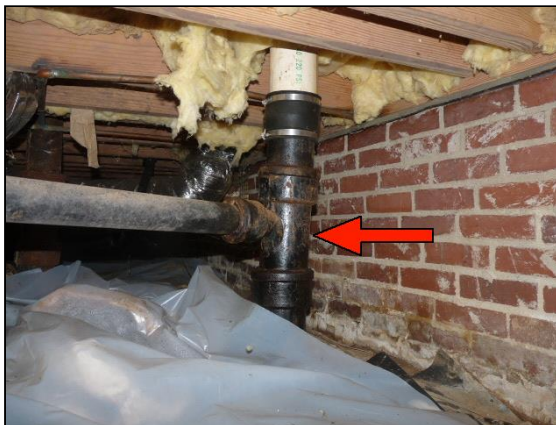
5.1 Several of the larger plumbing drains are cast iron and or galvanized metal. Some of these drains run underground. These drains can slowly clog or deteriorate from the inside. I cannot tell how clear or clogged the drains are today. The house had functional drainage, this means two drains worked at the same time. Testing underground drains is outside the scope of a home inspection. If this is a concern you may at additional expense have the drains video scoped to give you a better indication of their serviceability. A licensed plumbing contractor or underground drain line installation contractor can perform this task and advise you. This is for your information.

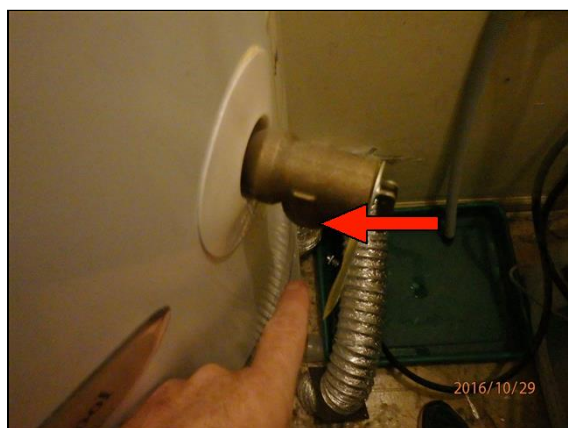
1

5.5 The water heater in the laundry room utility closet has the following issues. All should be corrected for proper functioning, to correct water seepage, leaks or prevent injuries. A licensed plumbing contractor or other qualified contractor with plumbing repair experience should repair or replace. A more specific contractor may be described below.

1. The water heater's temperature and pressure relief valve is missing the drain line. An accidental scalding could occur if the valve opens.
2. The hot water heater has been installed behind the washer and dryer. The hot water heater is not accessible without having to move the washer and dryer out of the way. Hot water heaters should be easily accessible.
3. The water heater inlet lines are flexible rubber braided lines. Most professionals do not use them because of high failure rates. Also the rubber deteriorates under pressure and heat and small flakes of the rubber end up in the water.

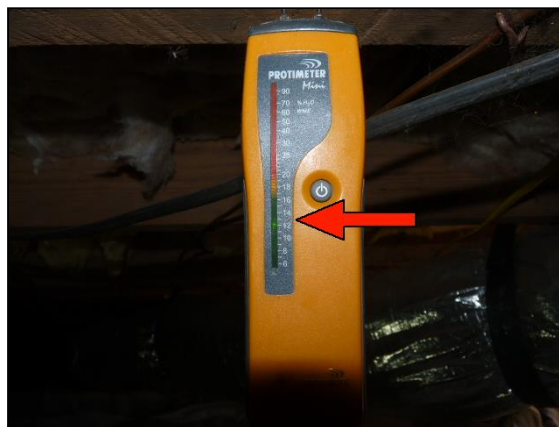
12%

6.0 A hand held moisture meter was used to check the moisture readings in the crawl space. The readings were within acceptable limits today. This is for your information.

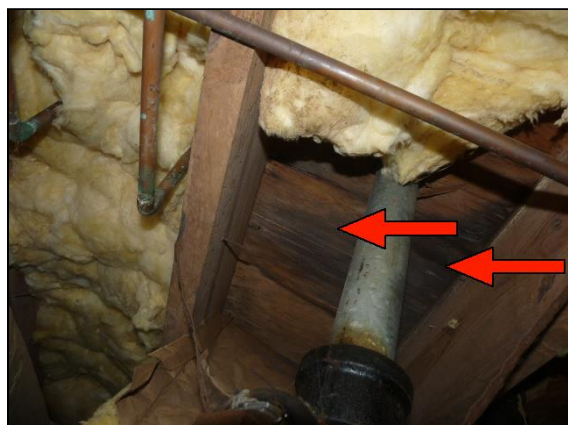
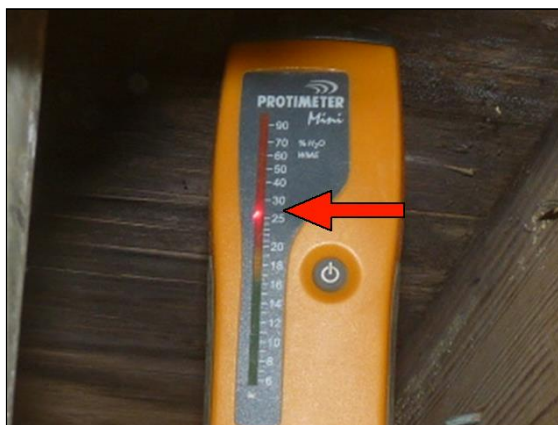
1

1. Facing front from outside(reference the front door). Then at the back of the crawl space. The plywood subflooring has dark stains and had moisture readings in excess of 25%. Evidence suggest the drain is leaking.

6.2 The following crawl space drains may have active small leaks. Repair the leaks and check for hidden contiguous wood/flooring damage. We run water through drains or fill tubs/showers/sinks with some water and then drain before entering the crawl space. A licensed plumbing contractor or other qualified person should repair or replace.

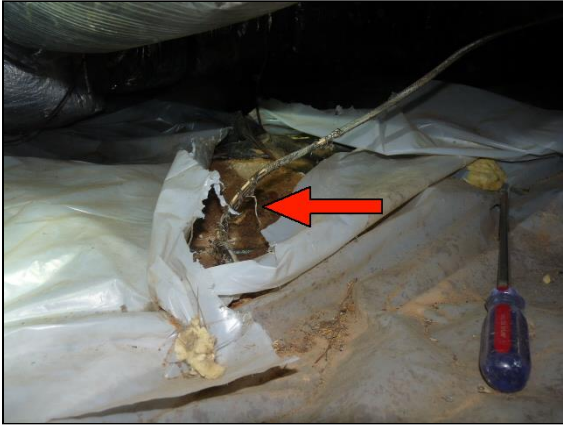
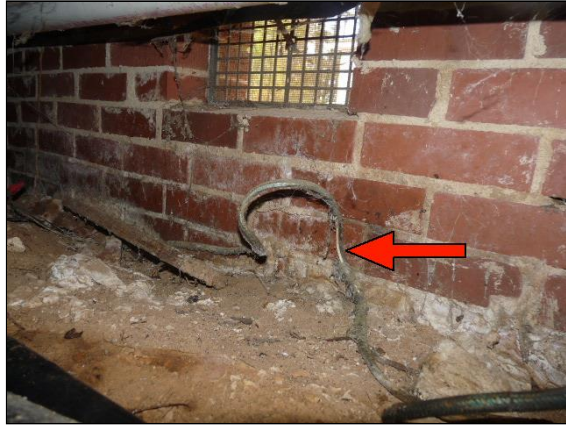
1

6.4 The crawl space has the following electrical issues. These are safety or property fire hazards. All should be corrected so they are safe for use and function as intended. A licensed electrical contractor, other qualified person with electrical repair experience or more specific person listed below should repair or replace.

1. There are several wires that appear to be abandoned. I did not test to see if these wires are still active.
2. The wiring has open/exposed splices or ends. This is an electric safety hazard. Most professionals agree that all splices should be in approved boxes. Just capping the ends with wire nuts or taping the ends is not considered safe enough. Abandoned wires or circuits should be removed.
3. The electric wires are loose and hanging down or are not attached to the wood members. This is a hazard to persons.

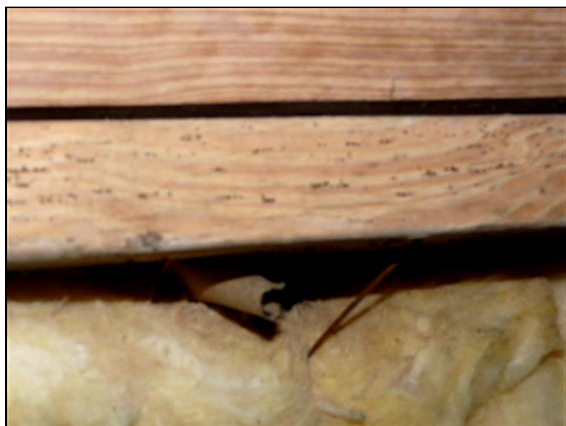
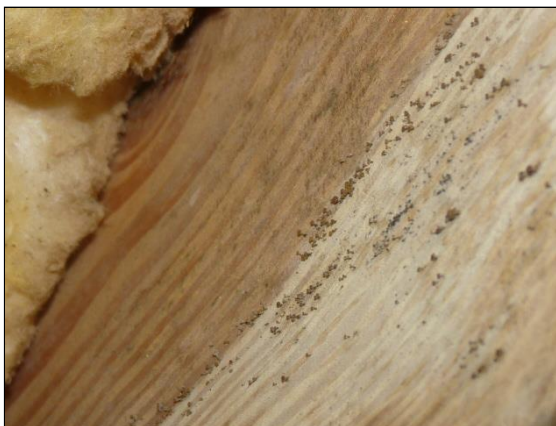
6.5 Crawl space. There are fungal growth on the wood framing. Fungal growths can be a health hazard and cause wood rot. Evidence suggests the cause is excess moisture from time to time. The summary will state if we noted excess or harmful moisture today. A licensed general or fungal remediation contractor should further investigate and correct as necessary and address the underlying cause to prevent reoccurrence.

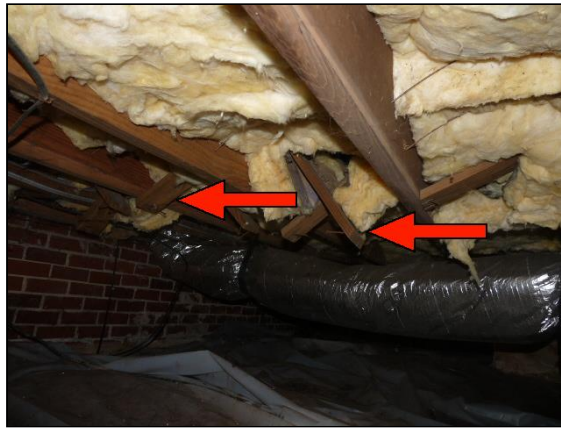
7.2 Crawl space. Several of the floor joists cross members are not secured or have come disconnected from the joists. These keep the joists from turning or rotating. A licensed general contractor or other qualified contractor should repair or replace.
